Materials Laboratory Division

Investigation Into Trans World Airlines Flight 800

Breakup Sequence Presentation

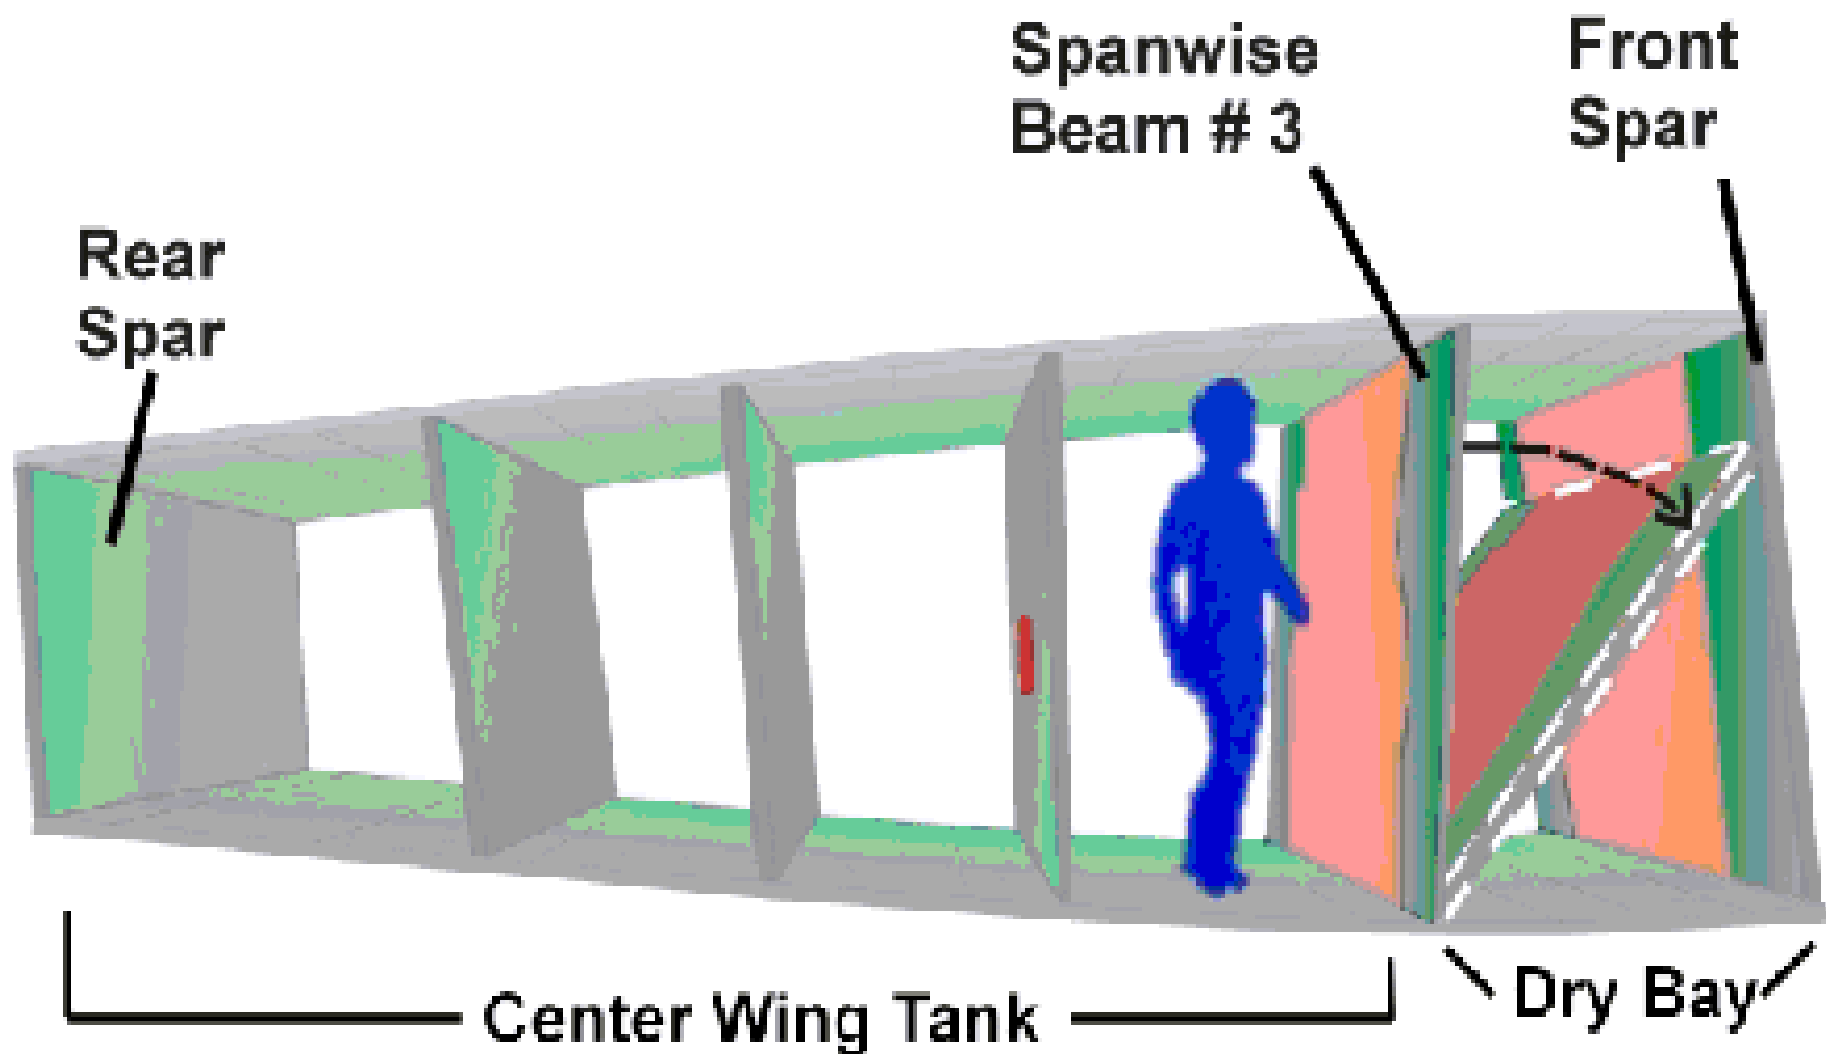
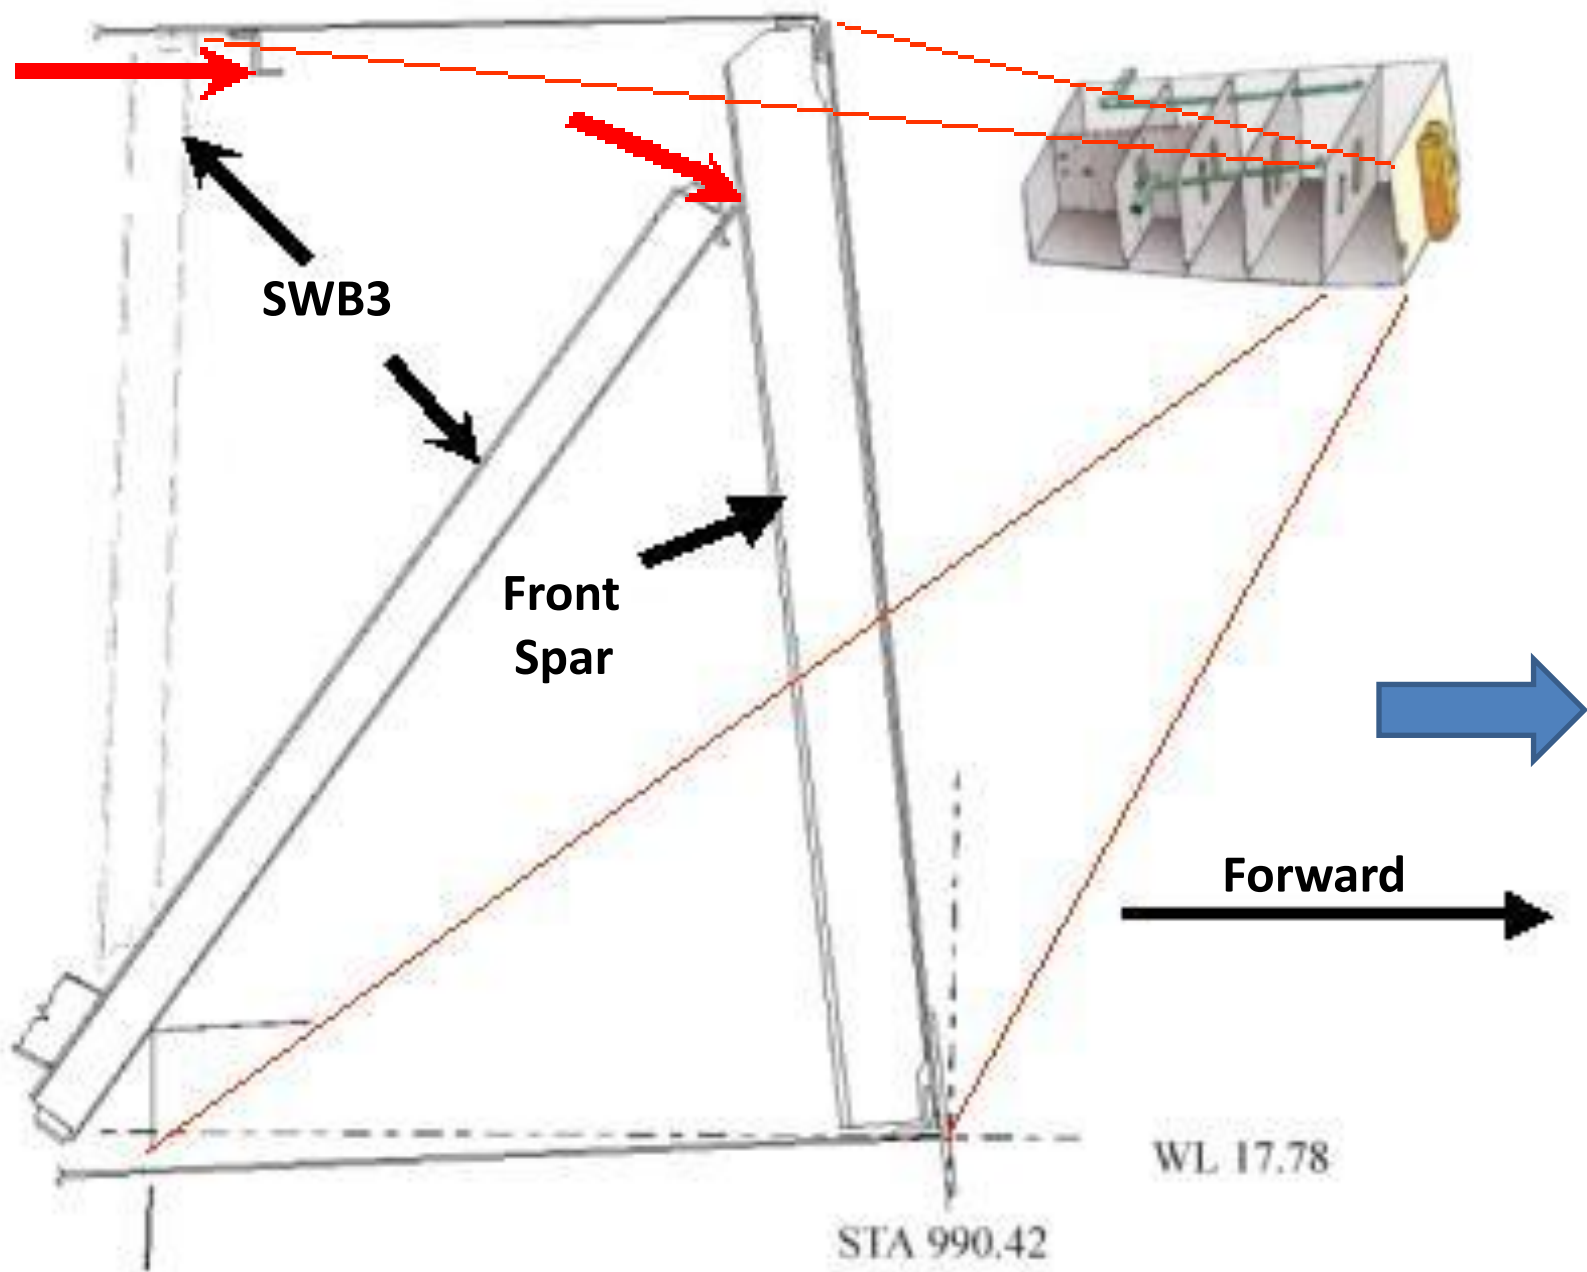
Spanwise beam 3 fractured at its upper end,
then
rotated forward

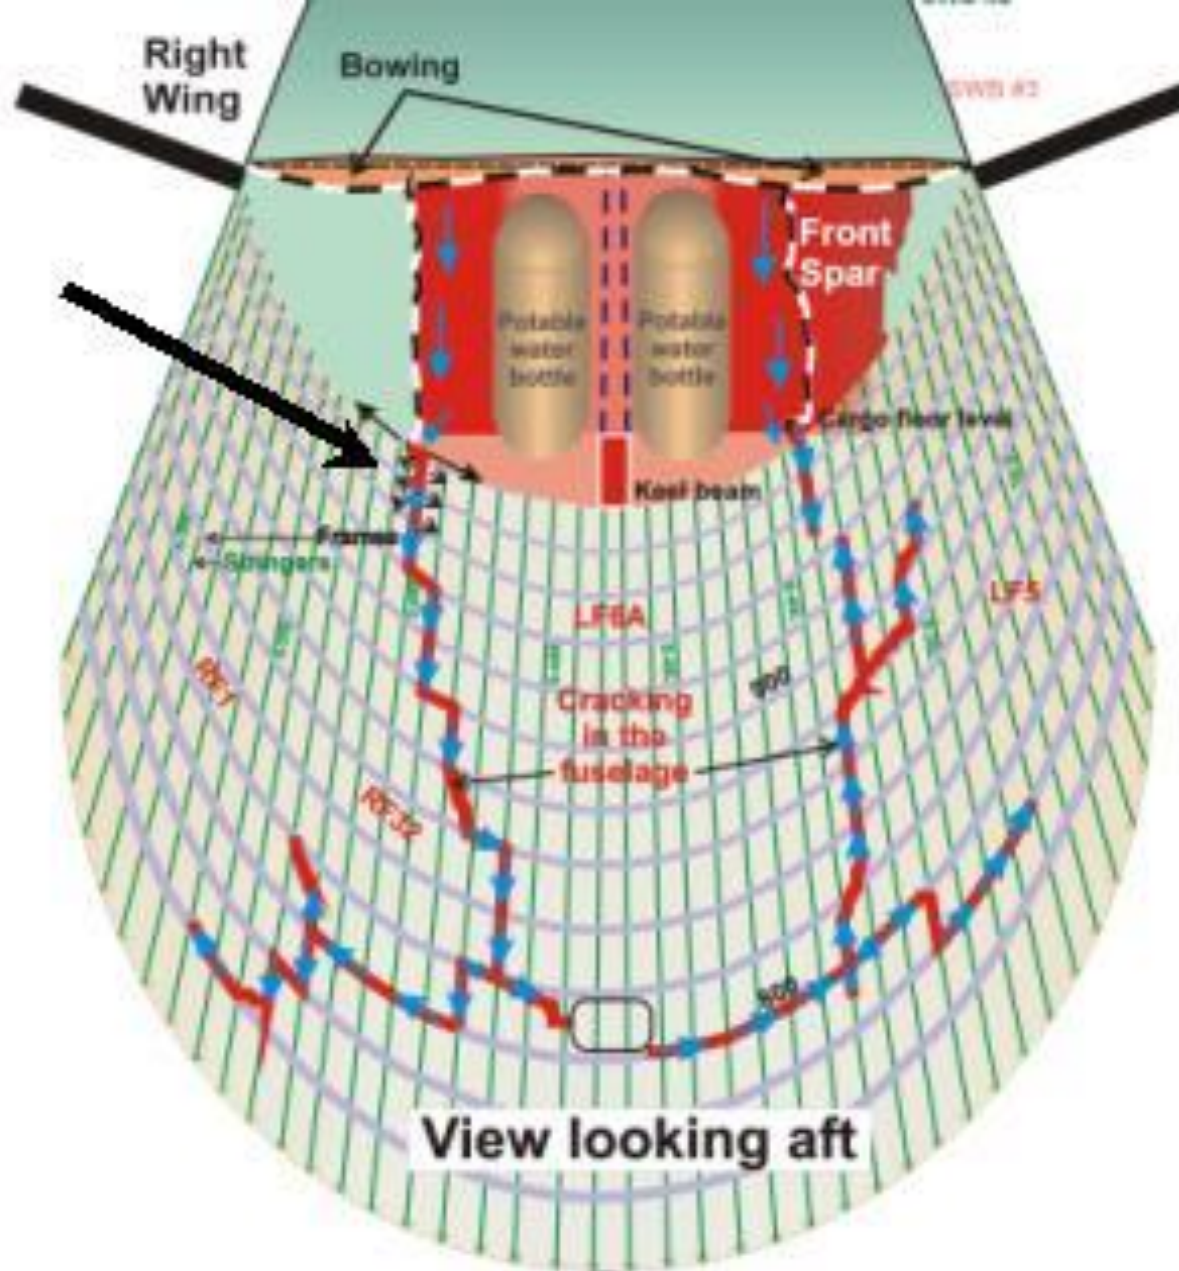
Fuselage
Cracking
Initiation
Area

Front spar fractured, progressed downward,
and

entered the fuselage at stringer 40R
